FINAL REPORT

Estimated Airborne Releases of Plutonium during the 1969 Fire in Buildings 776-777

Task 2: Verification and Analysis of Source Terms

August 1999

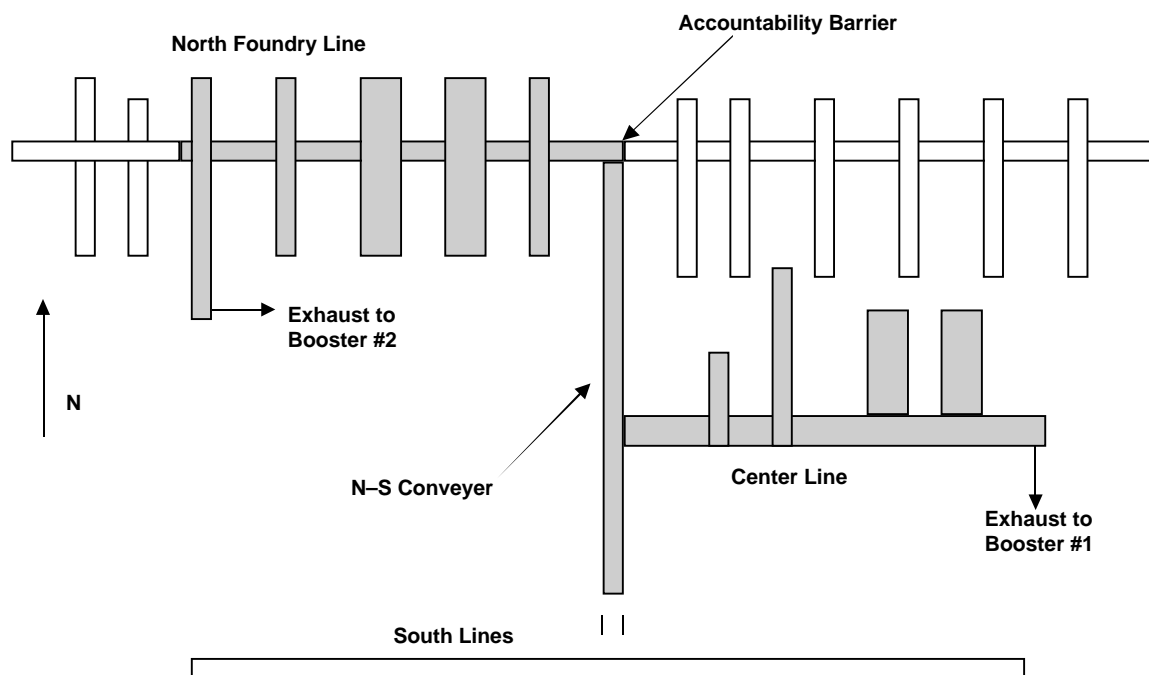
Figure 2.1 is a simple schematic diagram of portions of Buildings 776-777, that focuses on the glovebox lines affected by the fire. The figure is not to scale. The area of the fire was extremely congested. In this schematic, only outlines of the gloveboxes are shown. No attempt had been made to show the many individual work areas. The booster system exhausts are also shown in simplified manner, with only an indication of the direction of flow to the exhaust ducts. (Actually, there are several exhaust points along the line.) The south foundry and machining lines were unaffected by the fire on 11 May and are shown in even less detail.

Figure 2.1. Simplified diagram of glovebox lines in Buildings 776-777. Shaded areas were most affected by the fire on 11 May 1969. The drawing is schematic only; it is not to scale and many details are not included. The production area was much more congested than the diagram indicates.

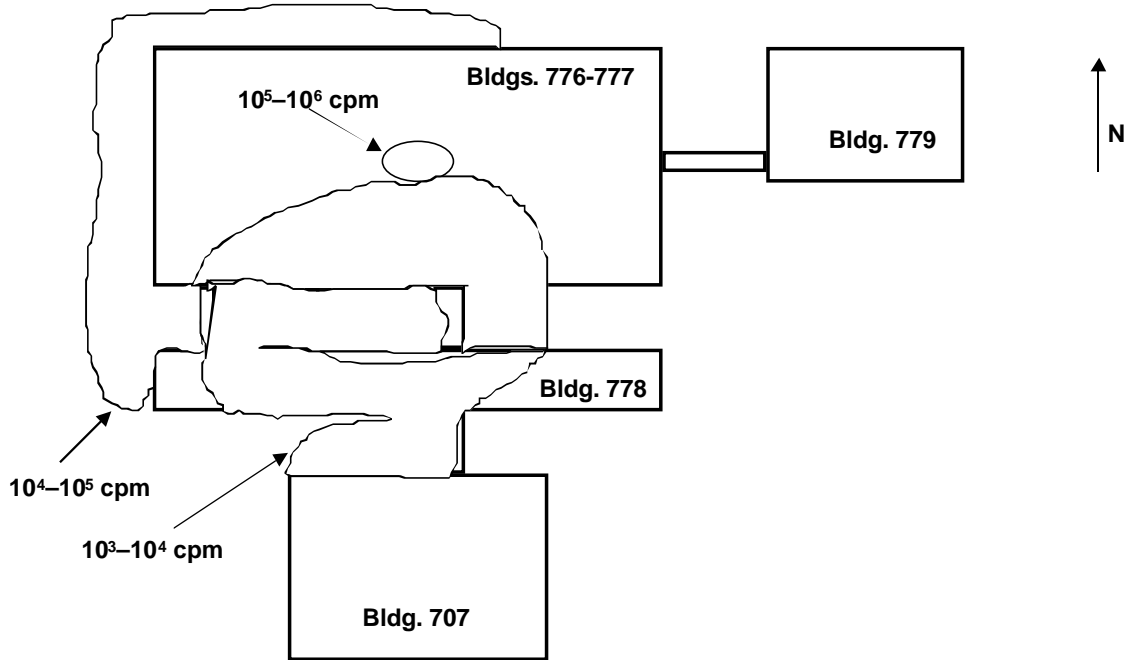
The plutonium contamination levels on the roof of Buildings 776-777 were measured after the fire. The area on the roof near the exhaust duct of Booster System No. 1 was the most highly contaminated, and the contamination pattern extended to the south and southwest from that area. [Figure 3.1](#) shows the main features of the original surface contamination map ([Freiberg 1969](#), [1999](#)) drawn by Freiberg after the fire. The drawing shows surface contamination levels on the

Figure 3.1. Map of surface contamination levels on and near Buildings 776-777 on 12 May. The map is not to scale or in full detail.

building roofs and on the ground. Ground surface contamination was found on the south, west, and north sides of the building. Most ground surface contamination was due to transport of plutonium out of the building on the shoes and clothing of fire fighters when it was necessary for them to obtain new air supplies. The firefighters used the west door for entry to and exit from the building.
